# **Yoma Central Project**

**Environmental Monitoring Report #3**

**Monitoring period April 2020 - September 2020**

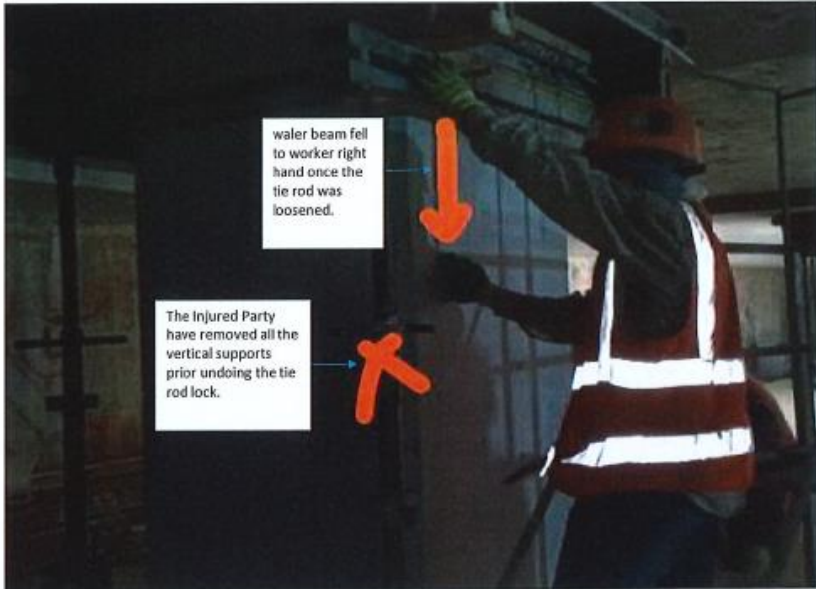
6.2 Detailed chronology of events (attach sketches, photos, testimony of the injured person, witnesses and line managers).

7. SOURCE CAUSES (Major and influential factors)		
Organisational and environmental		
Identified failures		Why ?
Method / Procedure	Method of de shuttering was not followed by the Injured Party	Instead of keeping the vertical supports of the water beam which is part of the formworks, the Injured Party have removed them prior undoing the tie rod lock connecting the two water beams.
Technical		
Identified failures		Why ?
People		
Identified failures		Why ?
Unsafe Act	Deliberate risk taking	The Injured Party intentionally didn't follow the Foreman's instruction to not remove the vertical supports prior loosening the tie rod lock connecting the two water beam. The worker was not wearing the issued gloves. The extent of the injury could have been reduce if the Injured Party wore his gloves.

8. CAUSE ANALYSIS / CORRECTIVE ACTIONS				
Immediate / direct causes identified*	Root causes identified*	Corrective actions to be implemented for each root cause identified	Person in charge / Job title	Target action date
Water beam fell to workers hand due to removed vertical supports	The Injured Party deliberately ignore the Foreman instruction to not remove the vertical supports.	issuance of disciplinary action against the Injured Party for deliberately disobeying the instruction of his superior. Reminder to be done to Supervisions that as much as possible that work instructions are conveyed repeatedly to ensure workers will not commit error. Those who deliberately ignore rules to be sanction or dismissed depending on the extent of the misdemeanour.	Delfin Peralza/Denis Neto Gomez	11/5/2020

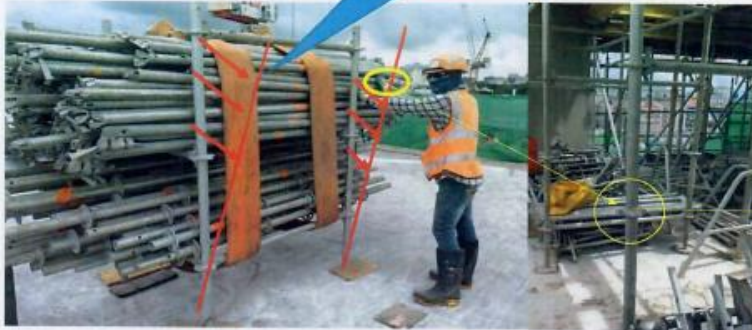
**Illustration**

Suspended on the crane however unbalance, both Injured Parties received the load by hands and attempted to push the load on the opposite side.

Finger caught here (in between the erected scaffold standard and the load being lifted).

7. SOURCE CAUSES (Major and influential factors)		
Organisational and environmental		
Identified failures		Why ?
Technical		
Identified failures		Why ?
People		
Identified failures		Why ?
Unsafe Act	Lack of due care and diligence	The Tower Crane Signalman allowed the two helpers to received the load with their hands without using the tagline or push sticks.
Unsafe Act	Lifting without ensuring a balance load	The accident could have been prevented if a test lift was undertaken by the rigger to ensure load is at center of gravity.

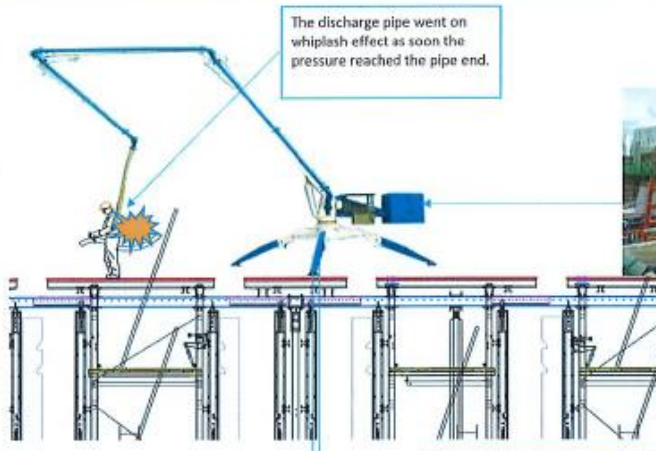
The discharge pipe went on whiplash effect as soon the pressure reached the pipe end.

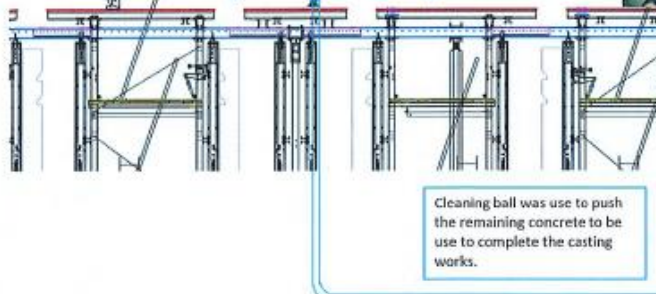
Cleaning ball was use to push the remaining concrete to be use to complete the casting works.

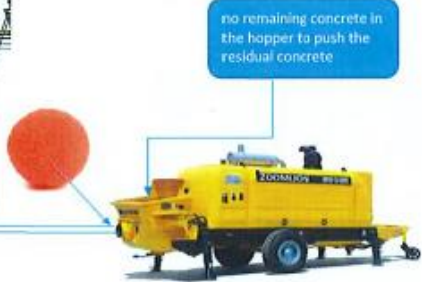
no remaining concrete in the hopper to push the residual concrete

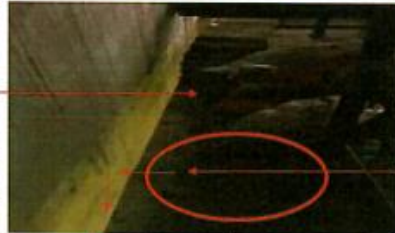
Due to frequent movement of the bottom platform the concrete debris fell from the gap.

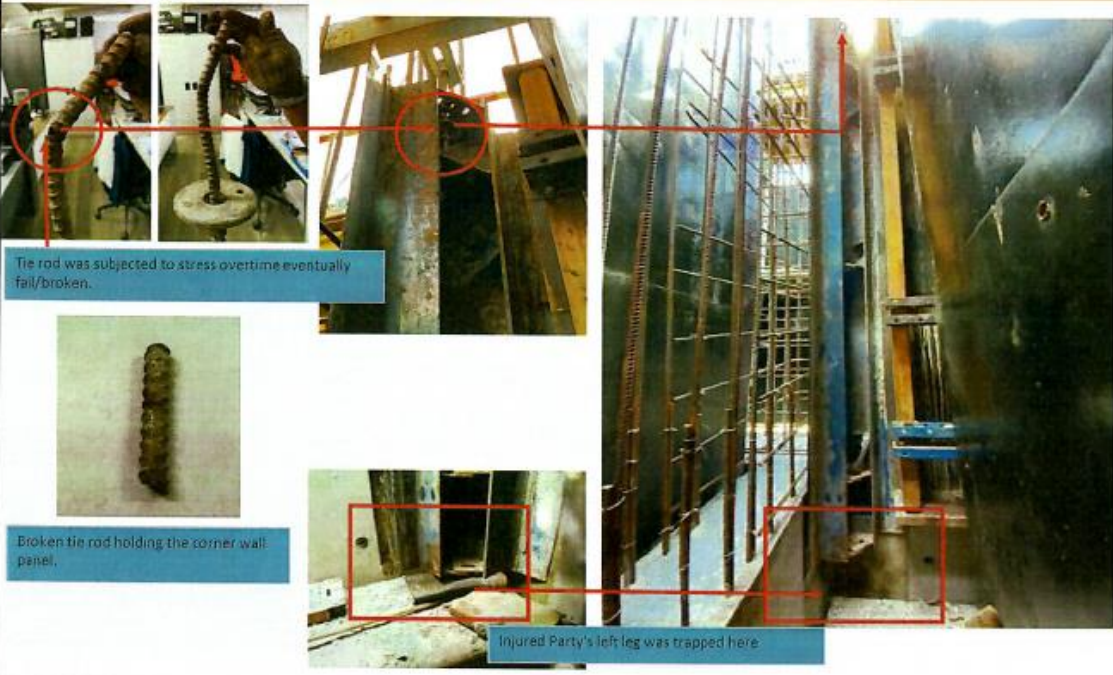
<p>Tie rod was subjected to stress overtime eventually fail/broken.</p> <p>Broken tie rod holding the corner wall panel.</p> <p>Injured Party's left leg was trapped here</p>		
6.3 List of elements and collected documents		
NIL
