# **Yoma Central Project**

**Environmental Monitoring Report #3**

**Monitoring period April 2020 - September 2020**

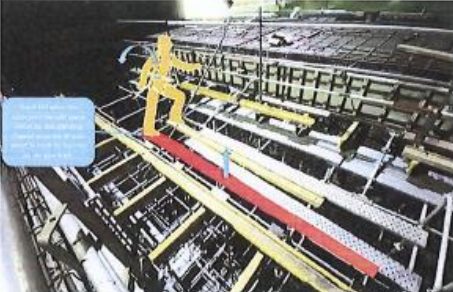
3.5 Characteristics of the working environment at the time of the accident (temperature, humidity, ground conditions, wind, noise environment, light...)			
Weather conditions :	0004 Temperature > 30°C		
More details :	Clear		
<p>On 4th April 2020 at approximately 9:30 PM, a worker (Ye Min Naing) fell from a 7.2 meters high shoring tower platform. Ye Min Naing was part of the team installing horizontal support of beam side forms. Ye Min (The Injured Party), was using three metallic planks and a 3.9 meters doka beam laid over the last lift of the shoring tower. The metallic planks and the doka beam were not tied and secured on the shoring tower. Ye Min was standing on the very last end of the doka and the metallic plank. And while he's about to hook his harness on a guardrails, the metallic plank where he's stepping on flip over causing him to fall. He landed on the crash deck of a provided walkway. He was immediately taken by his workmates to the site medical center. The Medical Officer on duty administered first aid and sent the Injured Party immediately to Yangon General Hospital using the ambulance onsite. The IP suffered fracture on the left wrist and small lacerated wound on the right hand including his chin and lips. Investigation revealed that no lifeline installed at the work location. The metallic planks being use are not securely tied on the shoring tower platform.</p>		<p>Visuals of the accidental occurrence (reconstruction, workstation, method statement...)</p>

Work suspended, area made safe and cordoned off. IP was sent to Yanqon General Hospital after receiving first aid treatment from the site medical center.

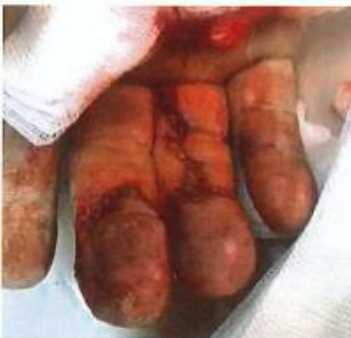
2.	YCP-098	08/05/2020	3:30 PM	Tank B3	IP got crushed injury on his right hand while he is undoing the tie rod lock connection the two waler beams on the formwork, the waler beam fell and subsequently hit to his right hand. At that time IP was not wearing his hand gloves.	BTJV	Notable	Area made safe. IP was immediately brought to site clinic where first aid was administered and later to YGH for further management.

3.5 Characteristics of the working environment at the time of the accident (temperature, humidity, ground conditions, wind, noise, illumination, light...)					
Weather conditions :	0004 Temperature > 30°C				
More details :	Clear				
<p>On 8th May 2020 at approximately 3:30 PM, Aung Kyaw Min (Team leader) was injured on the right hand (crushed injury). Aung Kyaw Min was a team leader engaged on deshuttering of grout column formwork at basement 3 tank. While he's undoing the tie rod lock connecting the two water beam on the formwork, the water beam fell and subsequently hit to his right hand. At the time the injured Party (Aung Kyaw Min) was not wearing his issued gloves. He have removed also the vertical supports to the water beam in which he's been told not to by his Foreman. Aung Kyaw Min received a first aid treatment at the site medical center and was sent to Yangon General Hospital. Fracture was found on the right index finger. The IP was admitted for the surgery.</p>			<p>Visuals of the accidental occurrence (reconstruction, workstation, method statement...)</p>

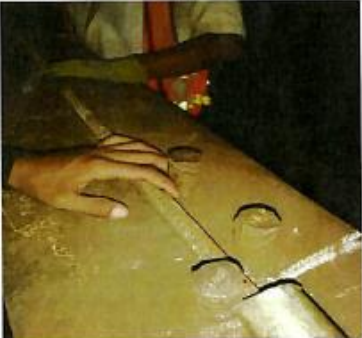
3.5 Characteristics of the working environment at the time of the accident (temperature, humidity, ground wet/slip, wind, noise, air pollutant, light...)			
Weather conditions :	0007 Cloudy		
More details :	Drizzle		
<p>On 05th August 2020, at approximately 2130H, a rebar worker (Myo Oo) accidentally caught his left index finger on the bending point i.e. in between a rebar and manual rebar bender while his workmate was bending a rebar. Myo Oo's workmate bend the rebar unknowingly that Myo's Oo finger is on the being point (line of fire). He was sent to site medical center where first aid treatment was given prior sending to YGH for further management. Surgery done to repair the tissue on his finger tip.</p>		<p>Visuals of the accidental occurrence (reconstruction, workstation, method statement...)</p>

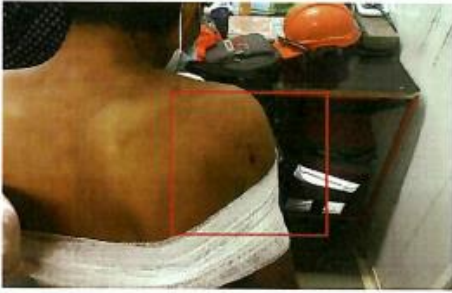
7.	YCP -108	7.9.2020	18:00	T3 L5	A concrete debris dropped from the deck of core wall 3.1 L5 to L4 subsequently hit to the worker's back resulting to abrasions and clavicle dislocation or fracture.	BTJV	Accident with lost time	First aid treatment given by immobilization of the clavicle prior sending to YGH.
8.	YCP -109	10.9.2020	8:30	CW 2.2 L11	A worker was injured on the left leg after struck by a falling corner wall panel used on the jump form. A tie rod used to secure the panel broke and fall to the worker's leg who is securing it with props at the bottom.	BTJV	Accident with lost time	First aid treatment given to IP at the site clinic and sent to YGH for further treatment.

3.5 Characteristics of the working environment at the time of the accident (temperature, humidity, ground conditions, wind, noise, vibration, light...)					
Weather conditions :	0907 Cloudy				
More details :	Drizzle				
At approximately 0600H on 7th September 2020, a concrete debris on the bottom deck of CW 3.1 tubeca platform fell from level 5 to level 4 subsequently hit to a worker's back resulting to abrasions and clavicle dislocation or fracture on the back. The fall distance is approximately 6 meters. The worker was treated on the site medical center (immobilization) prior sending to YGH for further management (to rule out fracture). Initial investigation revealed that during casting of core wall some concrete droppings ending up on platforms was missed to be cleaned and gets hardened. The platform where the concrete debris is located was frequently moving as it use as permanent access, due to shaking the concrete debris escape and fell through the gap.			Visuals of the accidental occurrence (reconstruction, workstation, method statement...)

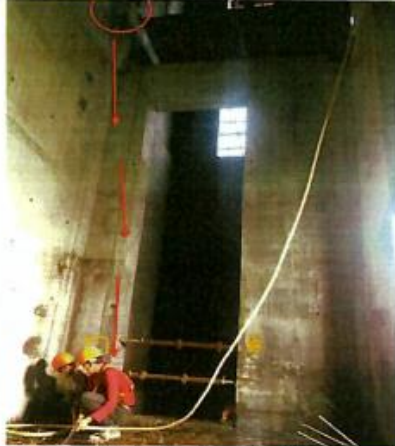
Due to frequent movement of the bottom platform the concrete debris fell from the gap.
